CONTOOCOOK RIVER BASIN
ANTRIM, NEW HAMPSHIRE

GREGG LAKE DAM
NH-00056
NHWRB-9.03

PHASE I INSPECTION REPORT
NATIONAL DAM INSPECTION PROGRAM

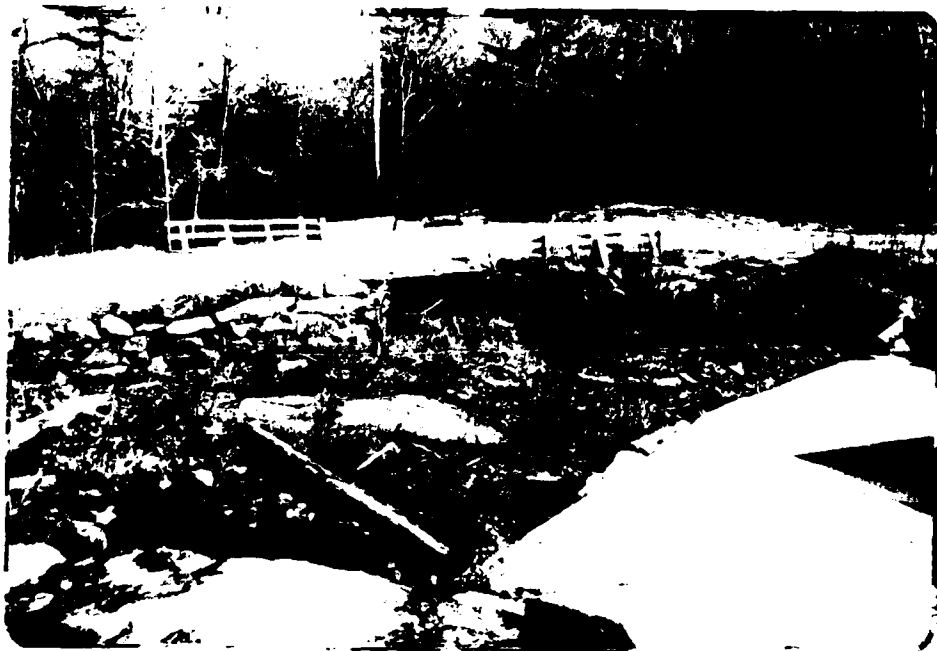
e. Downstream Channel. Great Brook immediately below the dam is composed of two channels which consist of ledge and cobbles as shown in Photos No. 2 and 3. The two channels join about 200 feet downstream of the dam. The banks of both channels are forested. Great Brook joins the Contoocook River about 3 1/2 miles below Gregg Lake Dam. The downstream channel is generally clear of debris and obstructions except for a road bridge which is located about 40 feet downstream of the dam. The bridge does not appear to cause submergence of the dam (see calculation Appendix D).

Downstream of Spillway

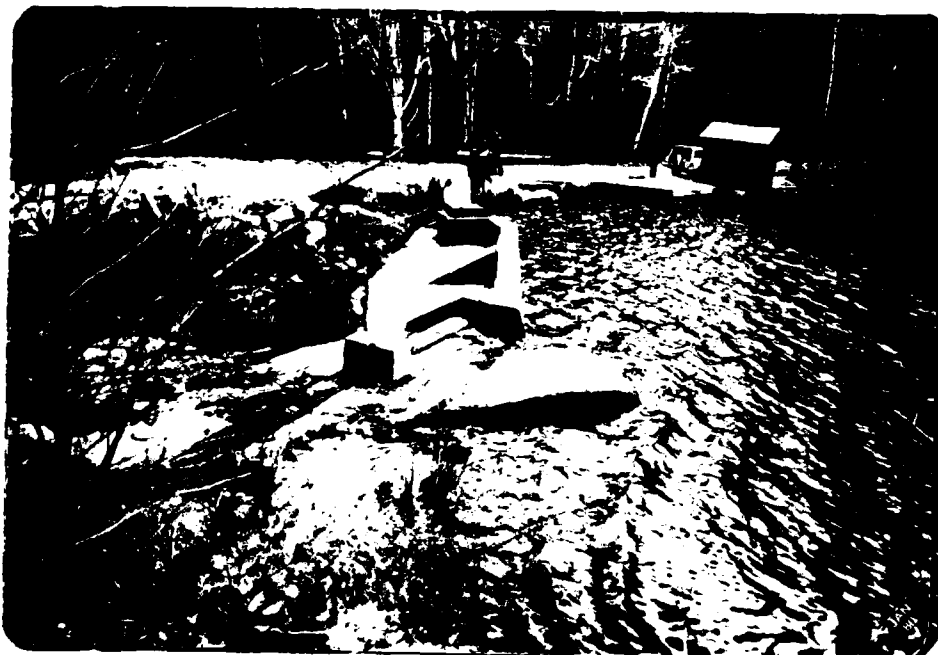
8.

- (d) The downstream face of the right embankment is a dry-laid stone masonry retaining wall which has been partially covered with earth fill (see photo No. 8). The wall is reported to have been a portion of the foundation for a mill that at one time abutted the downstream face of the embankment. Remnants of the mill foundation walls are located immediately downstream of the embankment. The wall appears to be in fair to good condition as shown in photo No. 4. Numerous trees up to 24 inches in diameter are located on the slope of the earth fill and along the top of the retaining wall.

View of Crest From Left Abutment.
